*Roof leaks in cold regions: School at Chevak, Alaska*

# CRREL Report 80-11

Wayne Tobiasson and Philip R. Johnson

April 1980

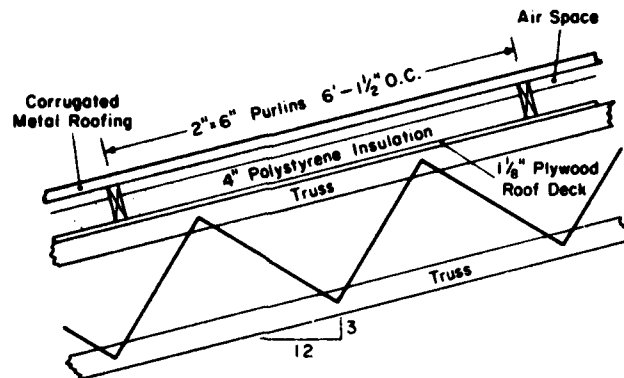
Figure 3. Cross section of roof.

The complex is elevated above the ice-rich permafrost on wooden piles. Wooden skirting, open near the ground, is present along the perimeter of the building. Glued laminated wooden floor beams placed on the piles support wood floor trusses. Steel and wooden columns and bearing walls with 2 × 6 studs support the roof which, like the floor, consists of glued laminated roof beams, wooden trusses and the roof itself. Each roof is sloped 3 on 12 and consists of a 1-1/8-in. plywood deck resting on the roof trusses. Above the plywood, 2 × 6 purlins run along the roof, 6 ft—1 1/2 in. on center, parallel to the eaves. Four inches of expanded bead polystyrene insulation is placed between the purlins which support corrugated metal roofing. This roof system is shown in Figure 3. No vapor barrier is indicated on the as-built drawings.
